Manhole Inspection Summary

Manhole # S25GG2013MH

Insp Date: **11/15/06 2:10 PM**

Location Address: **814 BELLEMORE RD**

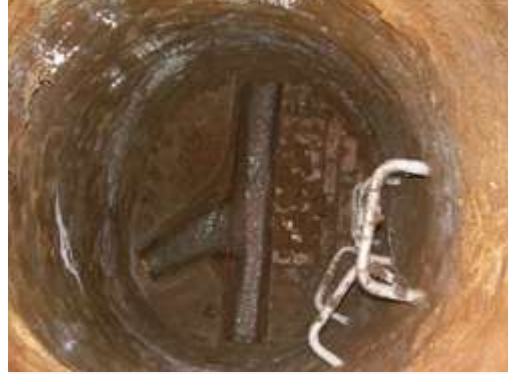
Top View

Bench debris.

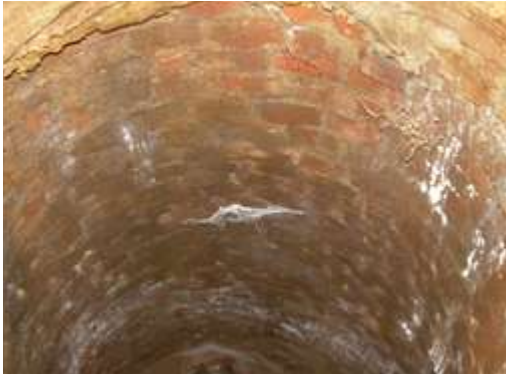
Defect

Infiltration: ☐ None ☒ **Joint** ☐ Cracks ☒ **Mortar** ☐ Roots ☐ Wall

Infiltration: ☐ None ☐ Joint ☐ Cracks ☒ **Mortar** ☐ Roots ☒ **Wall**

Adjustment, Corbel and Barrel infiltration.

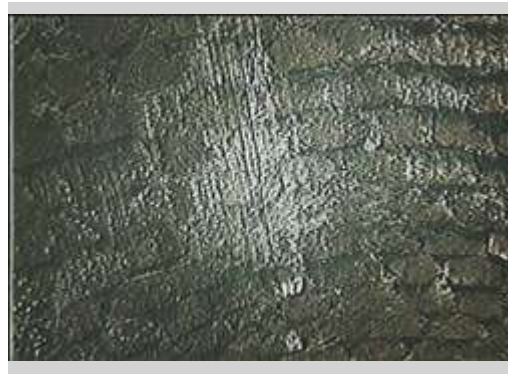
Defect

Condition: ☐ Sound ☐ Cracked ☐ Root Intrusion ☐ Loose Brick ☒ **Deteriorated**

Infiltration: ☐ None ☐ Joint ☐ Cracks ☒ **Mortar** ☐ Roots ☒ **Wall**

Barrel deterioration and infiltration.

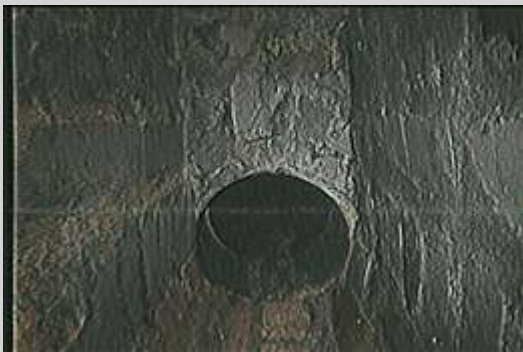
8 in. Circular Gravity Sewer Pipe Out @ 12 O'Clock

Infiltration: **None** Pipe Seal Cond: **Cracked**

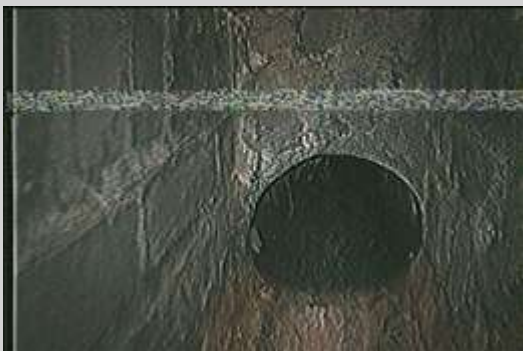
8 in. Circular Gravity Sewer Pipe In @ 6 O'Clock

Infiltration: **None** Pipe Seal Cond: **Cracked**

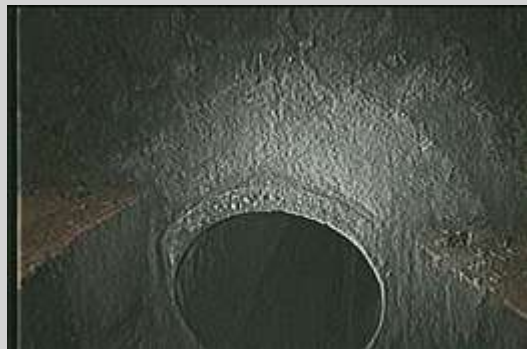
Pipe In @ 8 O'Clock

Pipe Seal Cond: **Unknown**
